PHOTO SUMMARY

Item # 5

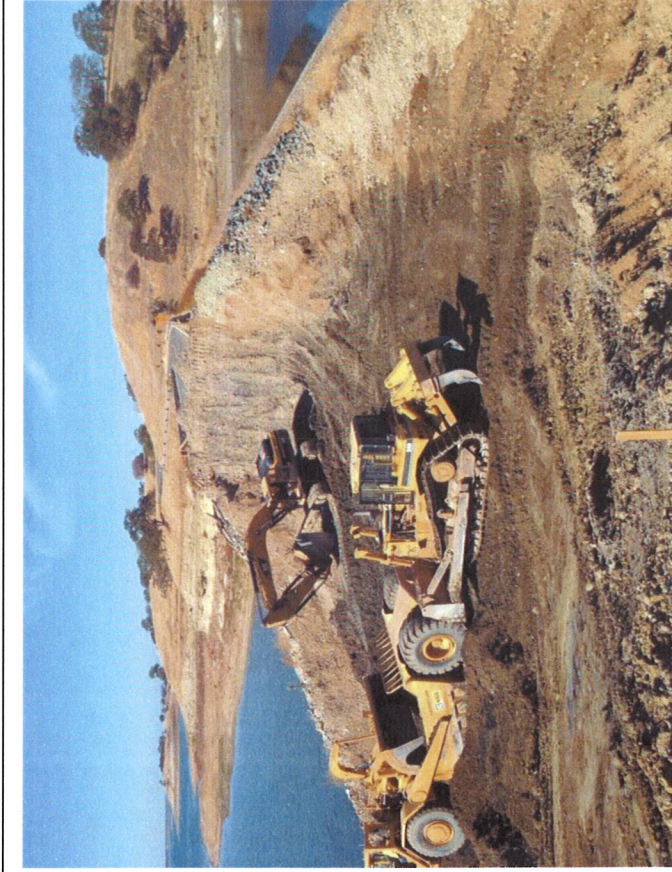
Looking west on the Causeway - Contractor excavating Causeway. The dark material is random material (dirt), which comprises the core of the Causeway. The light material on the right of the photograph is drain zone material (river rock and cobble), which comprises the outerlayer of the Causeway.

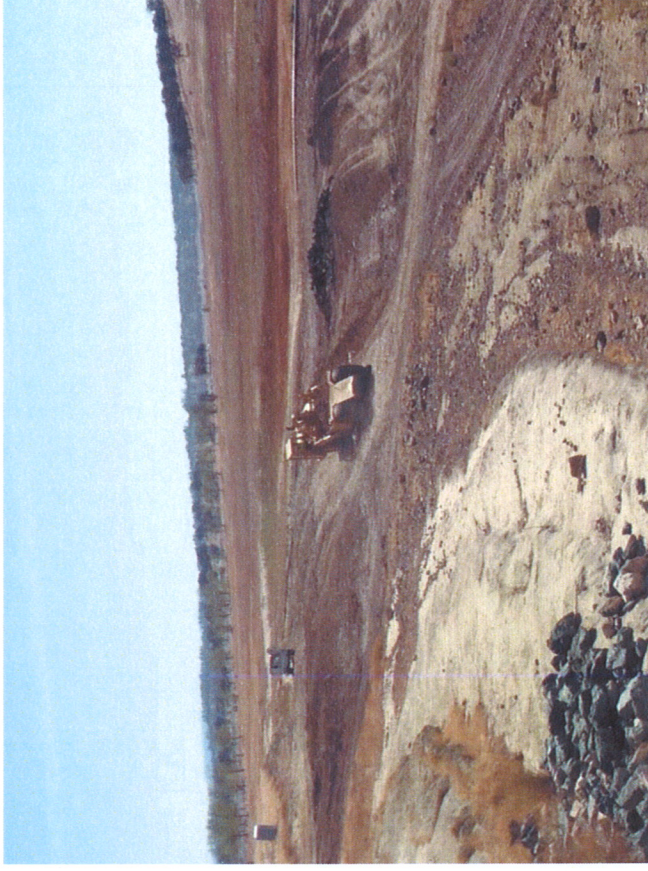
Looking south from Causeway - Scraper hauling and sorting engineered fill material excavated from Causeway to stockpiles. On the left, drain zone material (river rock and cobble). On the right, random material (dirt).

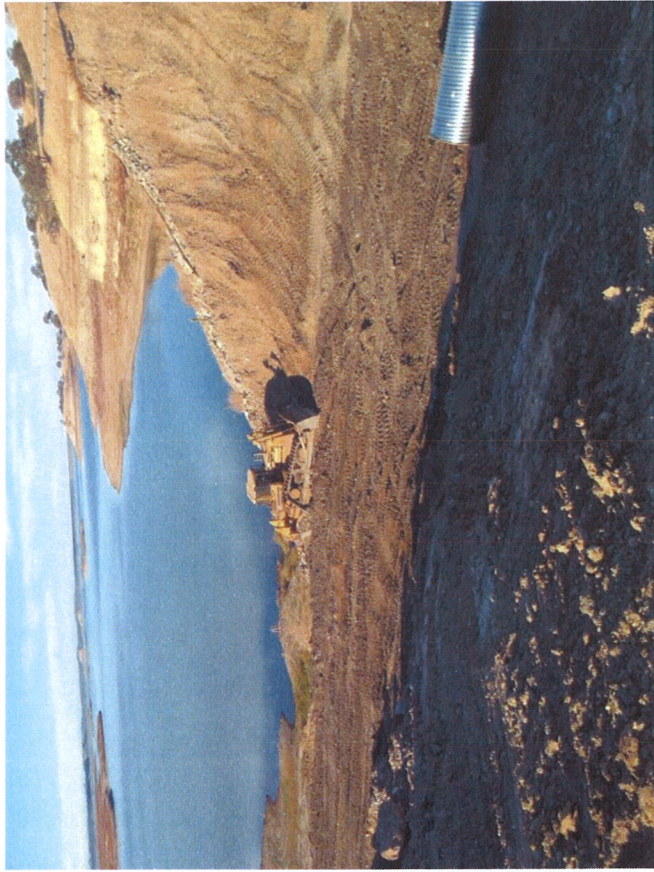
<p>Looking southwest on the Causeway towards Lake Camanche - Causeway excavation complete. Site being prepared for pipe installation the following day.</p>	<p>October 7, 2015</p>
---	---	------------------------

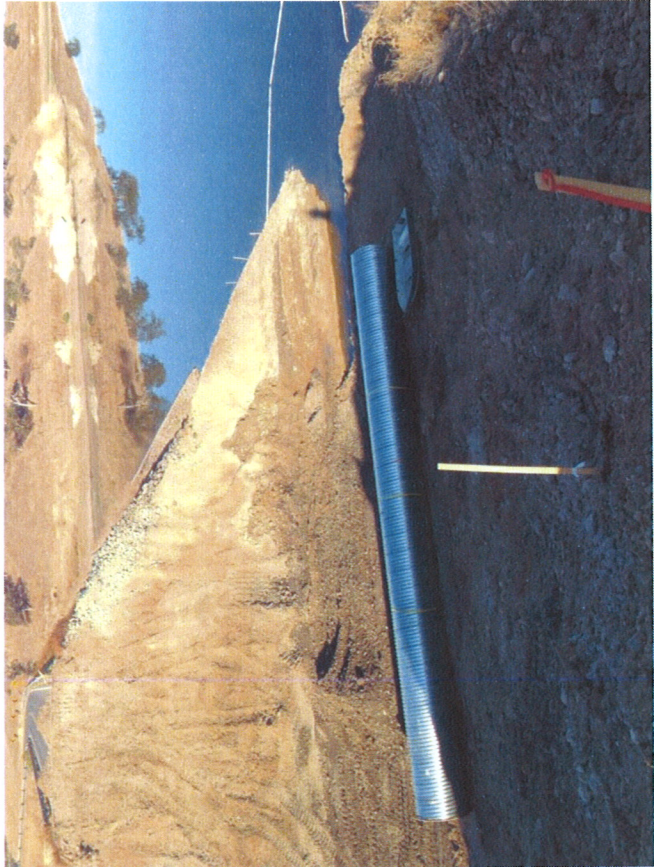
<p>Looking northwest from Causeway towards Rabbit Creek - 40 foot section of pipe ready for installation the next day. Note the water elevation difference elevation between the photograph on the left and this photograph. Water surface difference was approximately 20 feet.</p>	<p>October 7, 2015</p>
--	--	------------------------

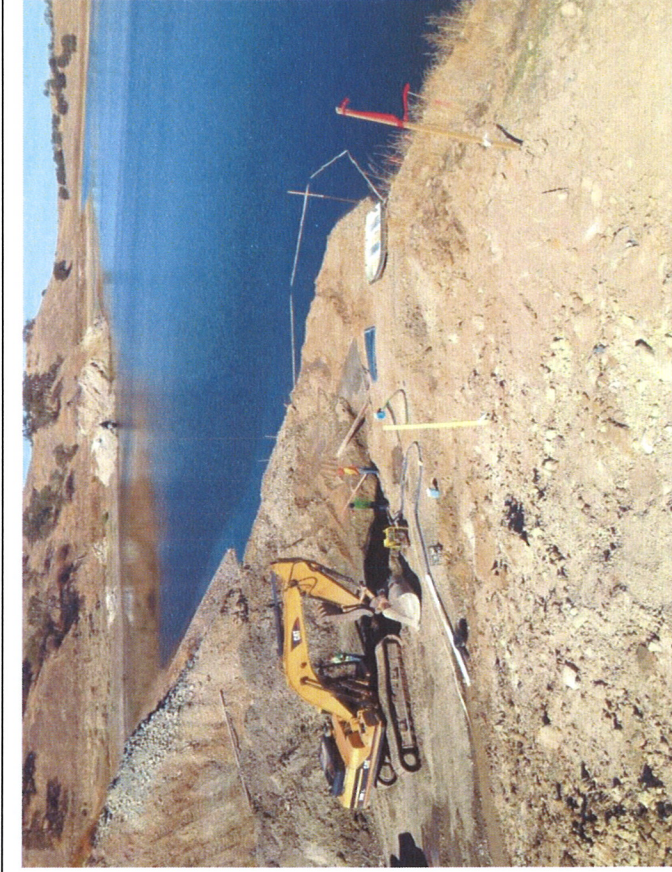
Looking northwest from Causeway towards Rabbit Creek - First 40 foot section of pipe installed with concrete backfill to seal seepage from Rabbit Creek

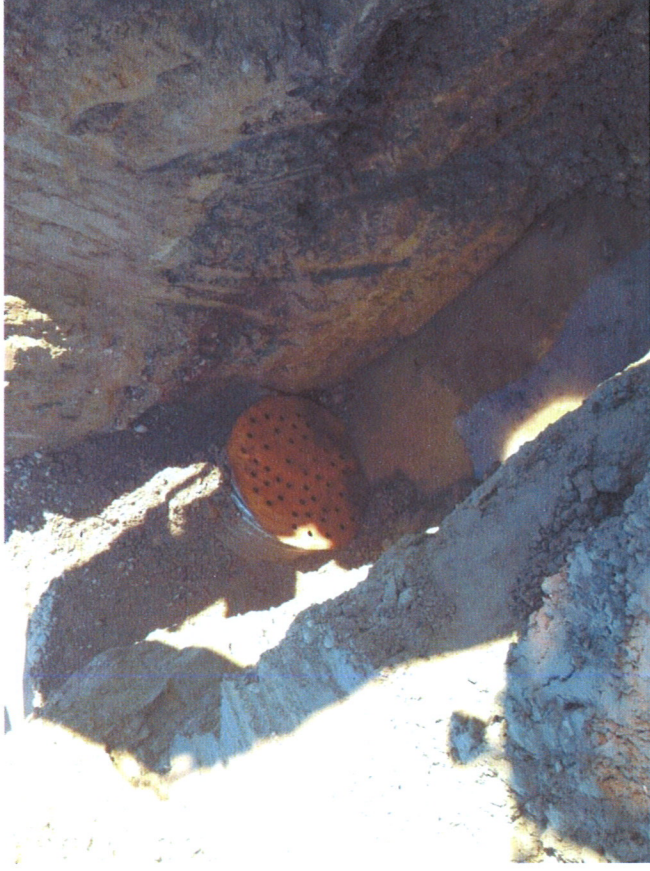
Looking down on the end of the newly installed 40 foot section of pipe, The next 20 foot section of pipe would be installed the following day.

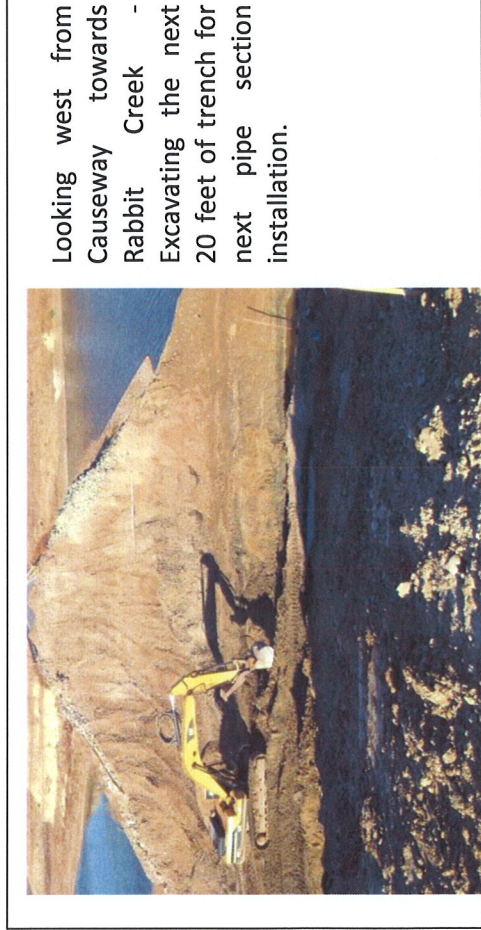
Looking west from Causeway towards Rabbit Creek - Excavating the next 20 feet of trench for next pipe section installation.

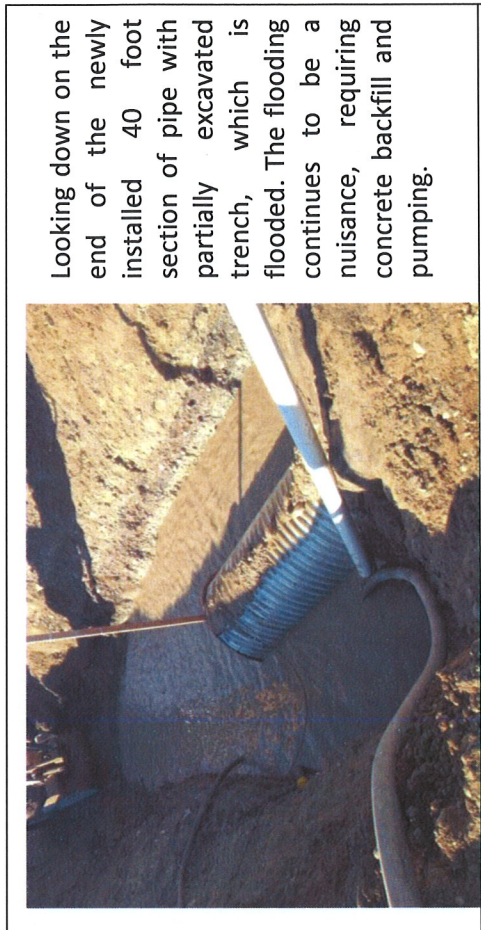
Looking down on the end of the newly installed 40 foot section of pipe with partially excavated trench, which is flooded. The flooding continues to be a nuisance, requiring concrete backfill and pumping.

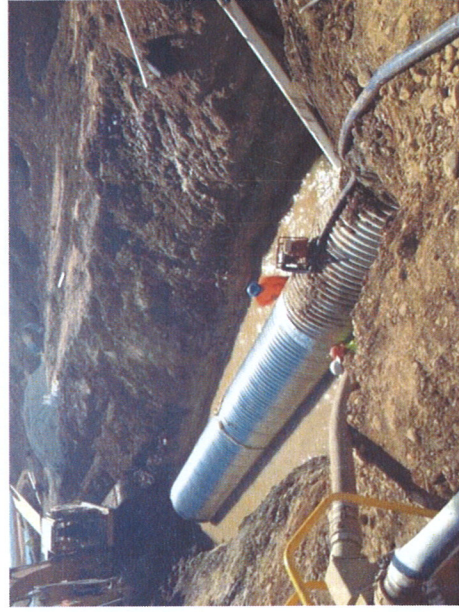
Looking down on the end of the newly installed 20 foot section of pipe. The trench remains flooded with multiple pumps working. Later in the day, about half the trench will be back filled with concrete, capping both culvert sections and joint.

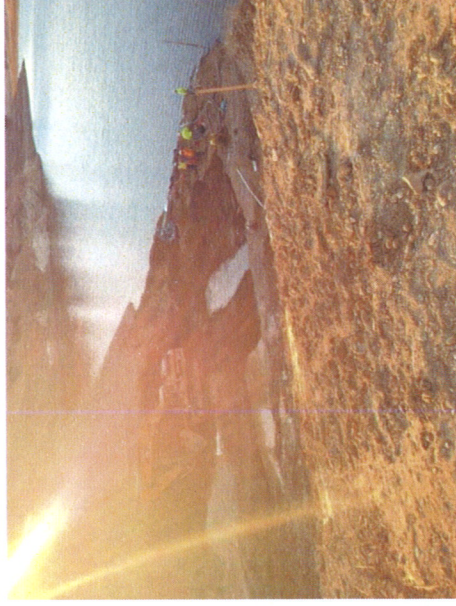
Looking northwest from Causeway towards Rabbit Creek - 20 foot section of pipe installed with concrete backfill to seal seepage from Rabbit Creek. Water still floods the end from inside the pipe. The inflatable plug installed at the end of the first section in

Rabbit Creek was not designed to be watertight.

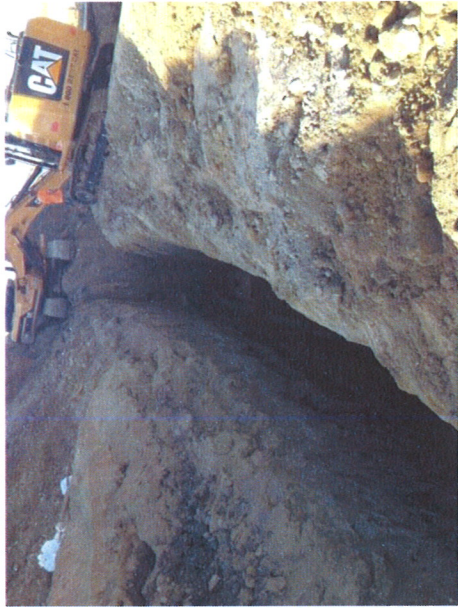
<p>Looking down on the end of the newly installed 20 foot section. Concrete cured over the weekend, sealing the sides of the trench. Water from Rabbit Creek still leaking through the pipe, causing flooding and pumps are failing. County and Contractor decide to being excavating bypass</p>	<p>Looking north along the temporary bypass trench that leads back to the flooded area at the pipe end.</p>

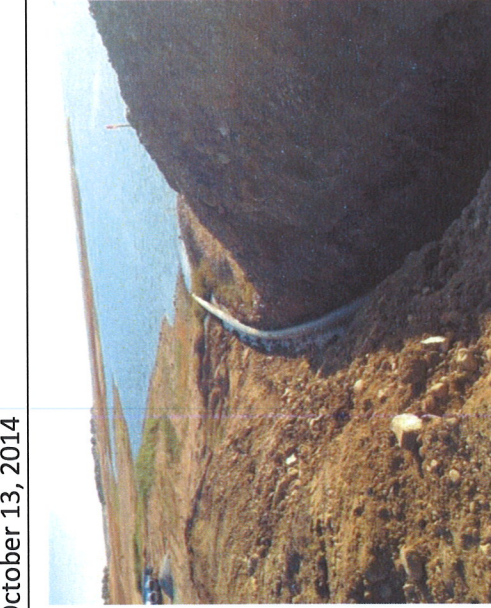
<p>Looking down on the pipe end when the bypass gravity drain is installed in the bypass trench. The drain is effective and dewaterers the trench nearly completely.</p>	<p>Looking south towards Lake Camanche showing the bypass drain and trench. The hose used for the drain was salvaged from the siphon that had been previously used to equalize Lake Camanche and Rabbit Creek.</p>
<p>October 13, 2014</p>	<p>October 13, 2014</p>

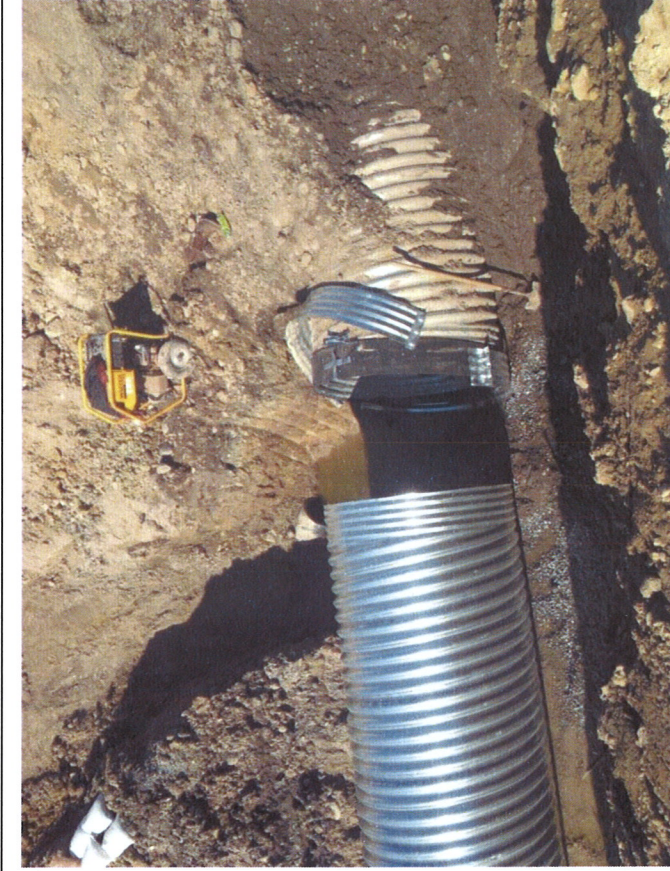
Looking down on the pipe end at the bypass drain. The drain remains effective and next pipe section is placed for installation.

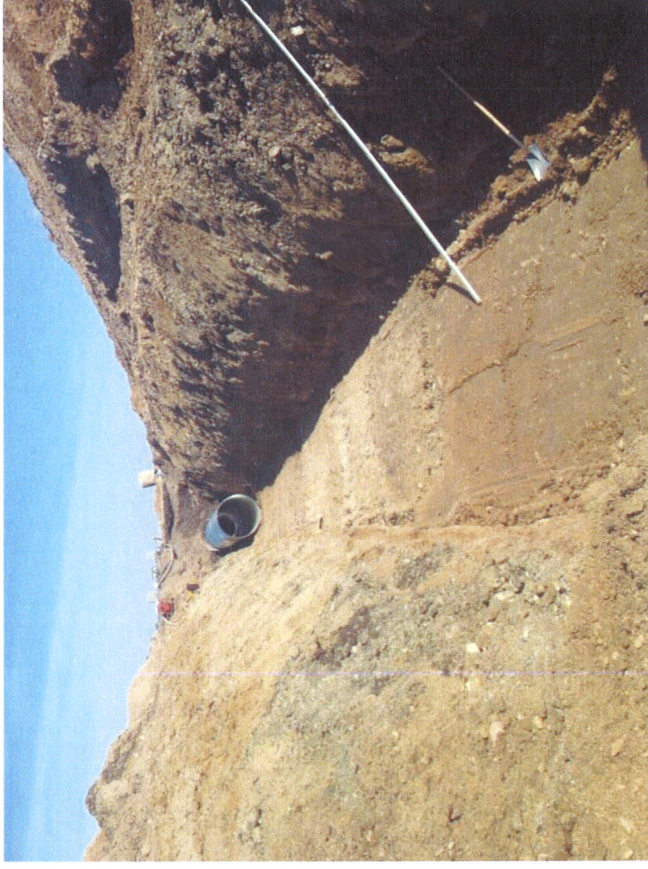
Looking north down the dry trench. The remaining pipe section were installed that day.

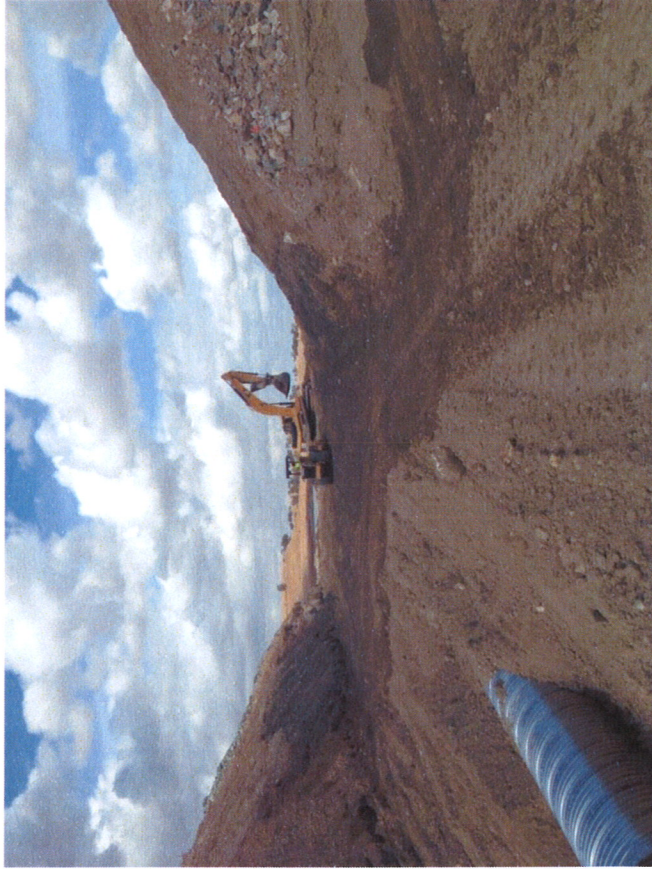
Looking north towards Rabbit Creek. Pipe is installed and backfilled. Preparations for reconstruction of the Causeway are underway.

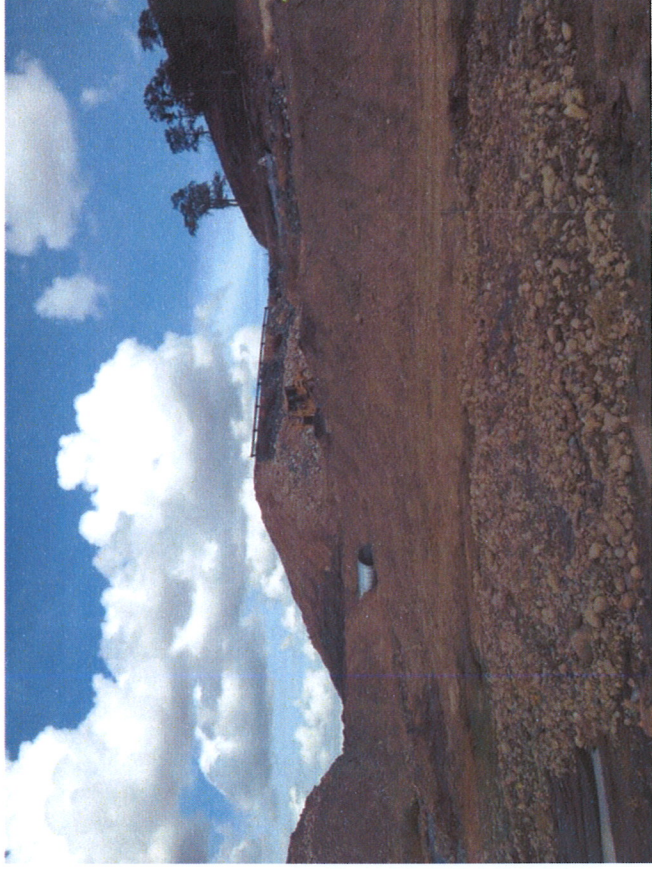
Looking northeast towards the pipe outlet from the water edge of Lake Camanche.

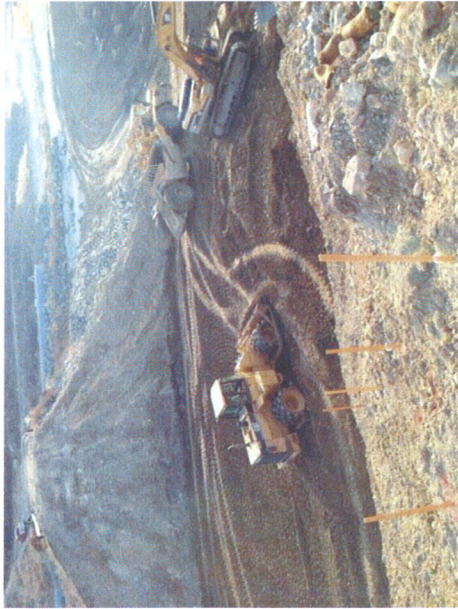
<p>Looking east viewing the reconstruction of the Causeway. Contractor placing and compacting the stockpiled material.</p>	<p>October 17, 2014</p>

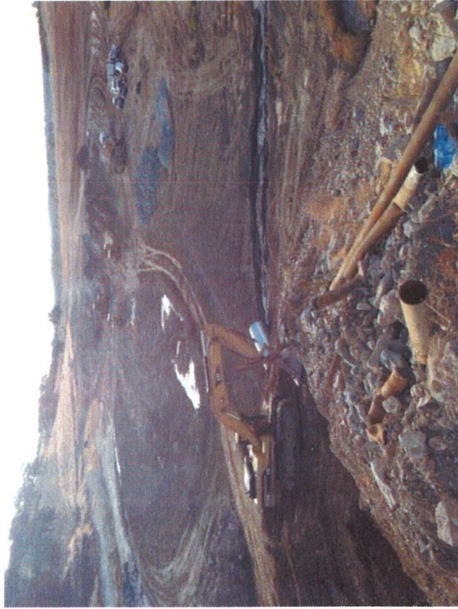
<p>Looking northeast showing the placement of the engineering embankment. Note the outerlayer drain zone material in contrast to the darker random zone material.</p>	<p>October 17, 2014</p>

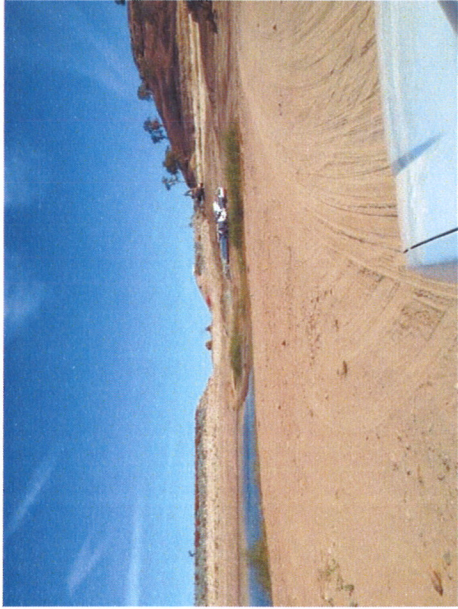
<p>Looking north from Lake Camanche towards Causeway</p>

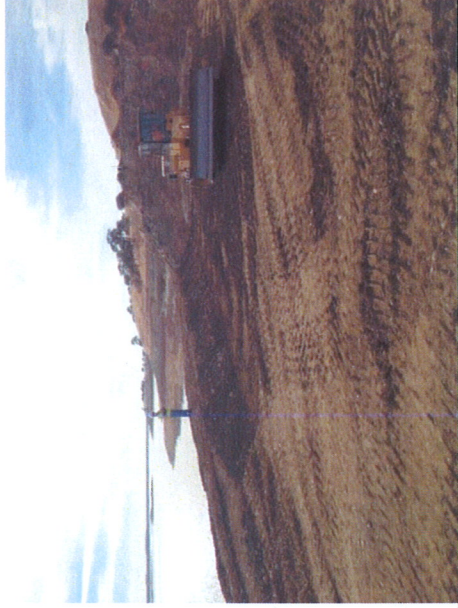
<p>Placing material and compacting</p>
<p>October 21, 2014</p>	<p>October 23, 2014</p>

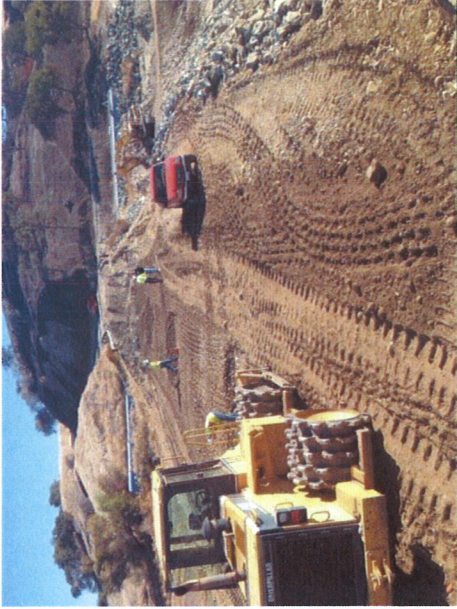
<p>Compaction Testing</p>

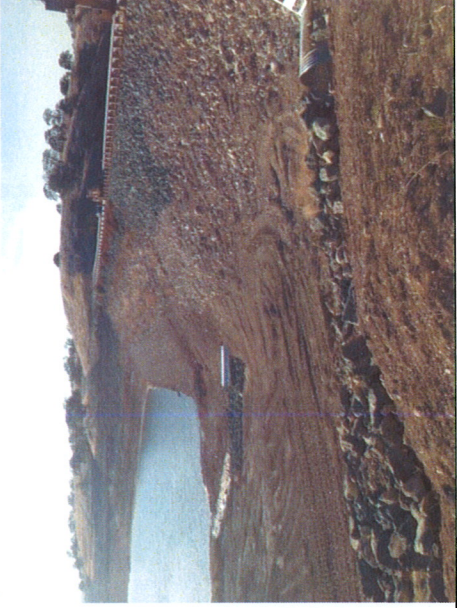
<p>Looking west - Causeway reconstruction nearly complete, except for paving on Camanche Parkway North.</p>
<p>October 28, 2014</p>	<p>November 3, 2014</p>

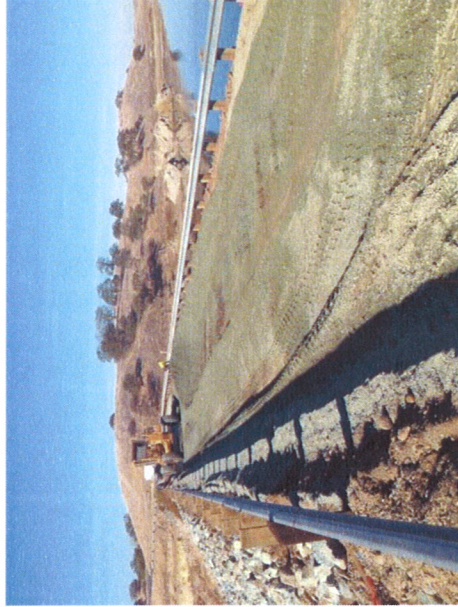
<p>Placing aggregate base</p>

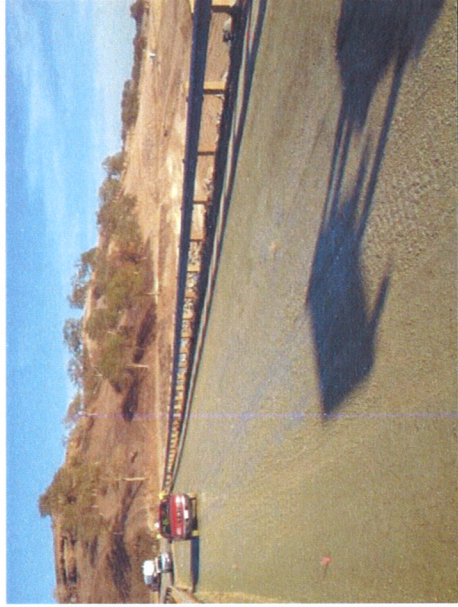
<p>Aggregate base placed and ready for paving</p>

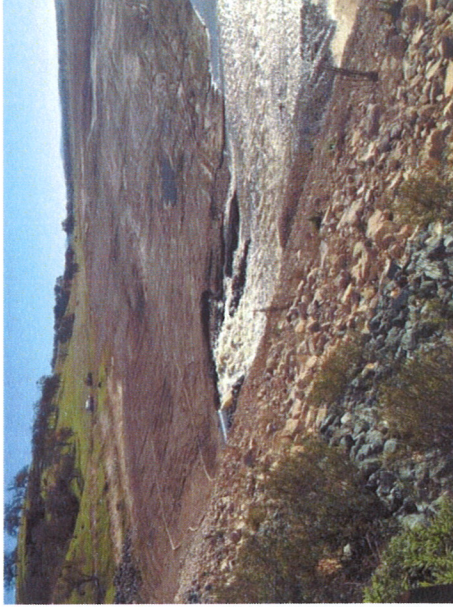
<p>Inflatable plug failure and Rabbit Creek begins to drain</p>

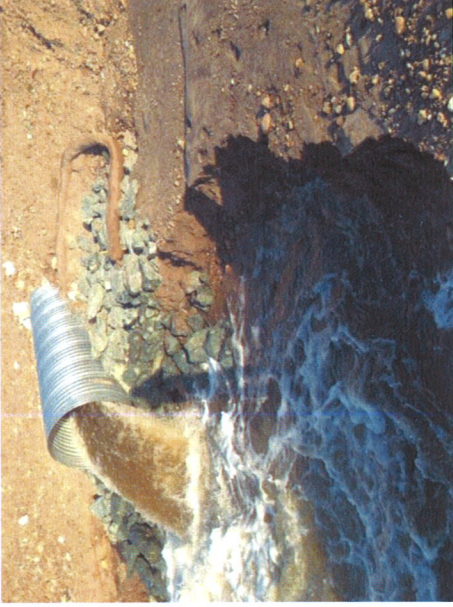
<p>View of scour damage at the Lake Camanche outlet a few days after pipe plug failure.</p>
<p>November 5, 2014</p>	<p>November 6, 2014</p>
<p>December 31, 2014</p>	<p>January 2, 2015</p>

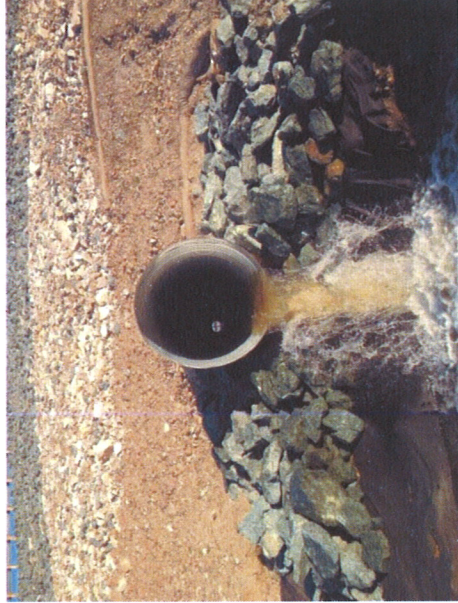
<p>Discharge scoured away the top 10 feet of soil along with the 1/4 ton rock apron leaving a hole with a pool of water. See daylight at the other end of pipe in Rabbit Creek.</p>

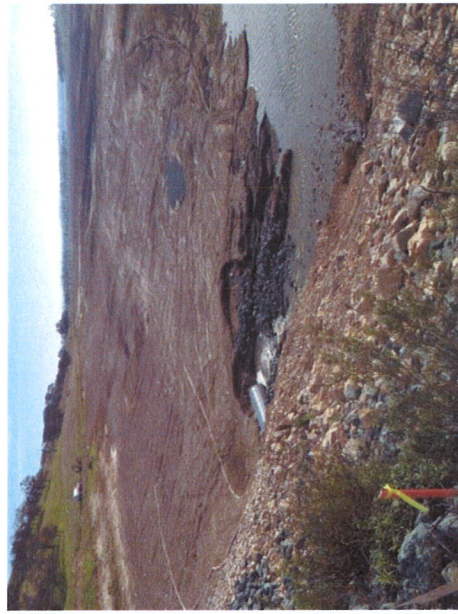
<p>Rabbit Creek is nearly drained to elevation 195. Shown here is view of the scour damage and the destroyed 1/4 rock apron</p>

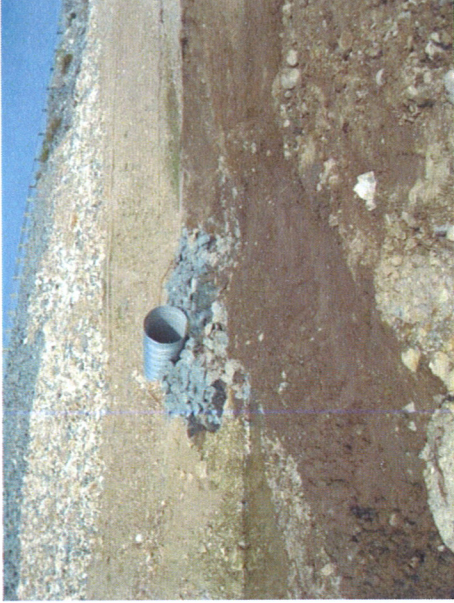
<p>View of culvert outlet repair on the Lake Camanche side. The scour hole was filled in and the area reshaped by County Forces. A limited 1/4 ton rock apron was reconstructed.</p>

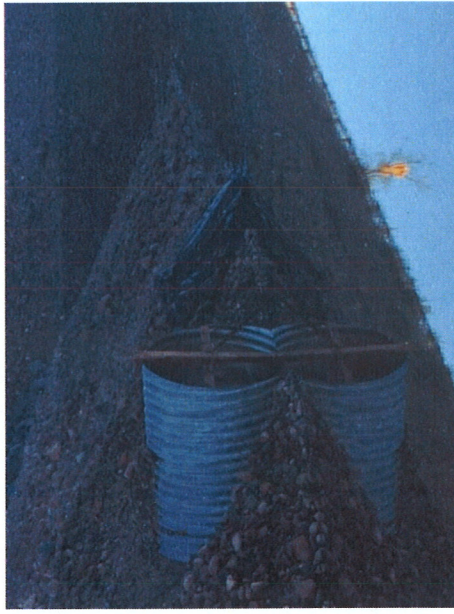
<p>View of exposed culvert end in Rabbit Creek. The cross bracing at the end of the pipe was later removed by EBMUD.</p>
