# Delineation of Waters of the U.S. and State

SPECIALTY GRANULES (IONE) LLC - IONE QUARRY EXPANSION  
PROJECT  
AMADOR COUNTY, CALIFORNIA

October 2020

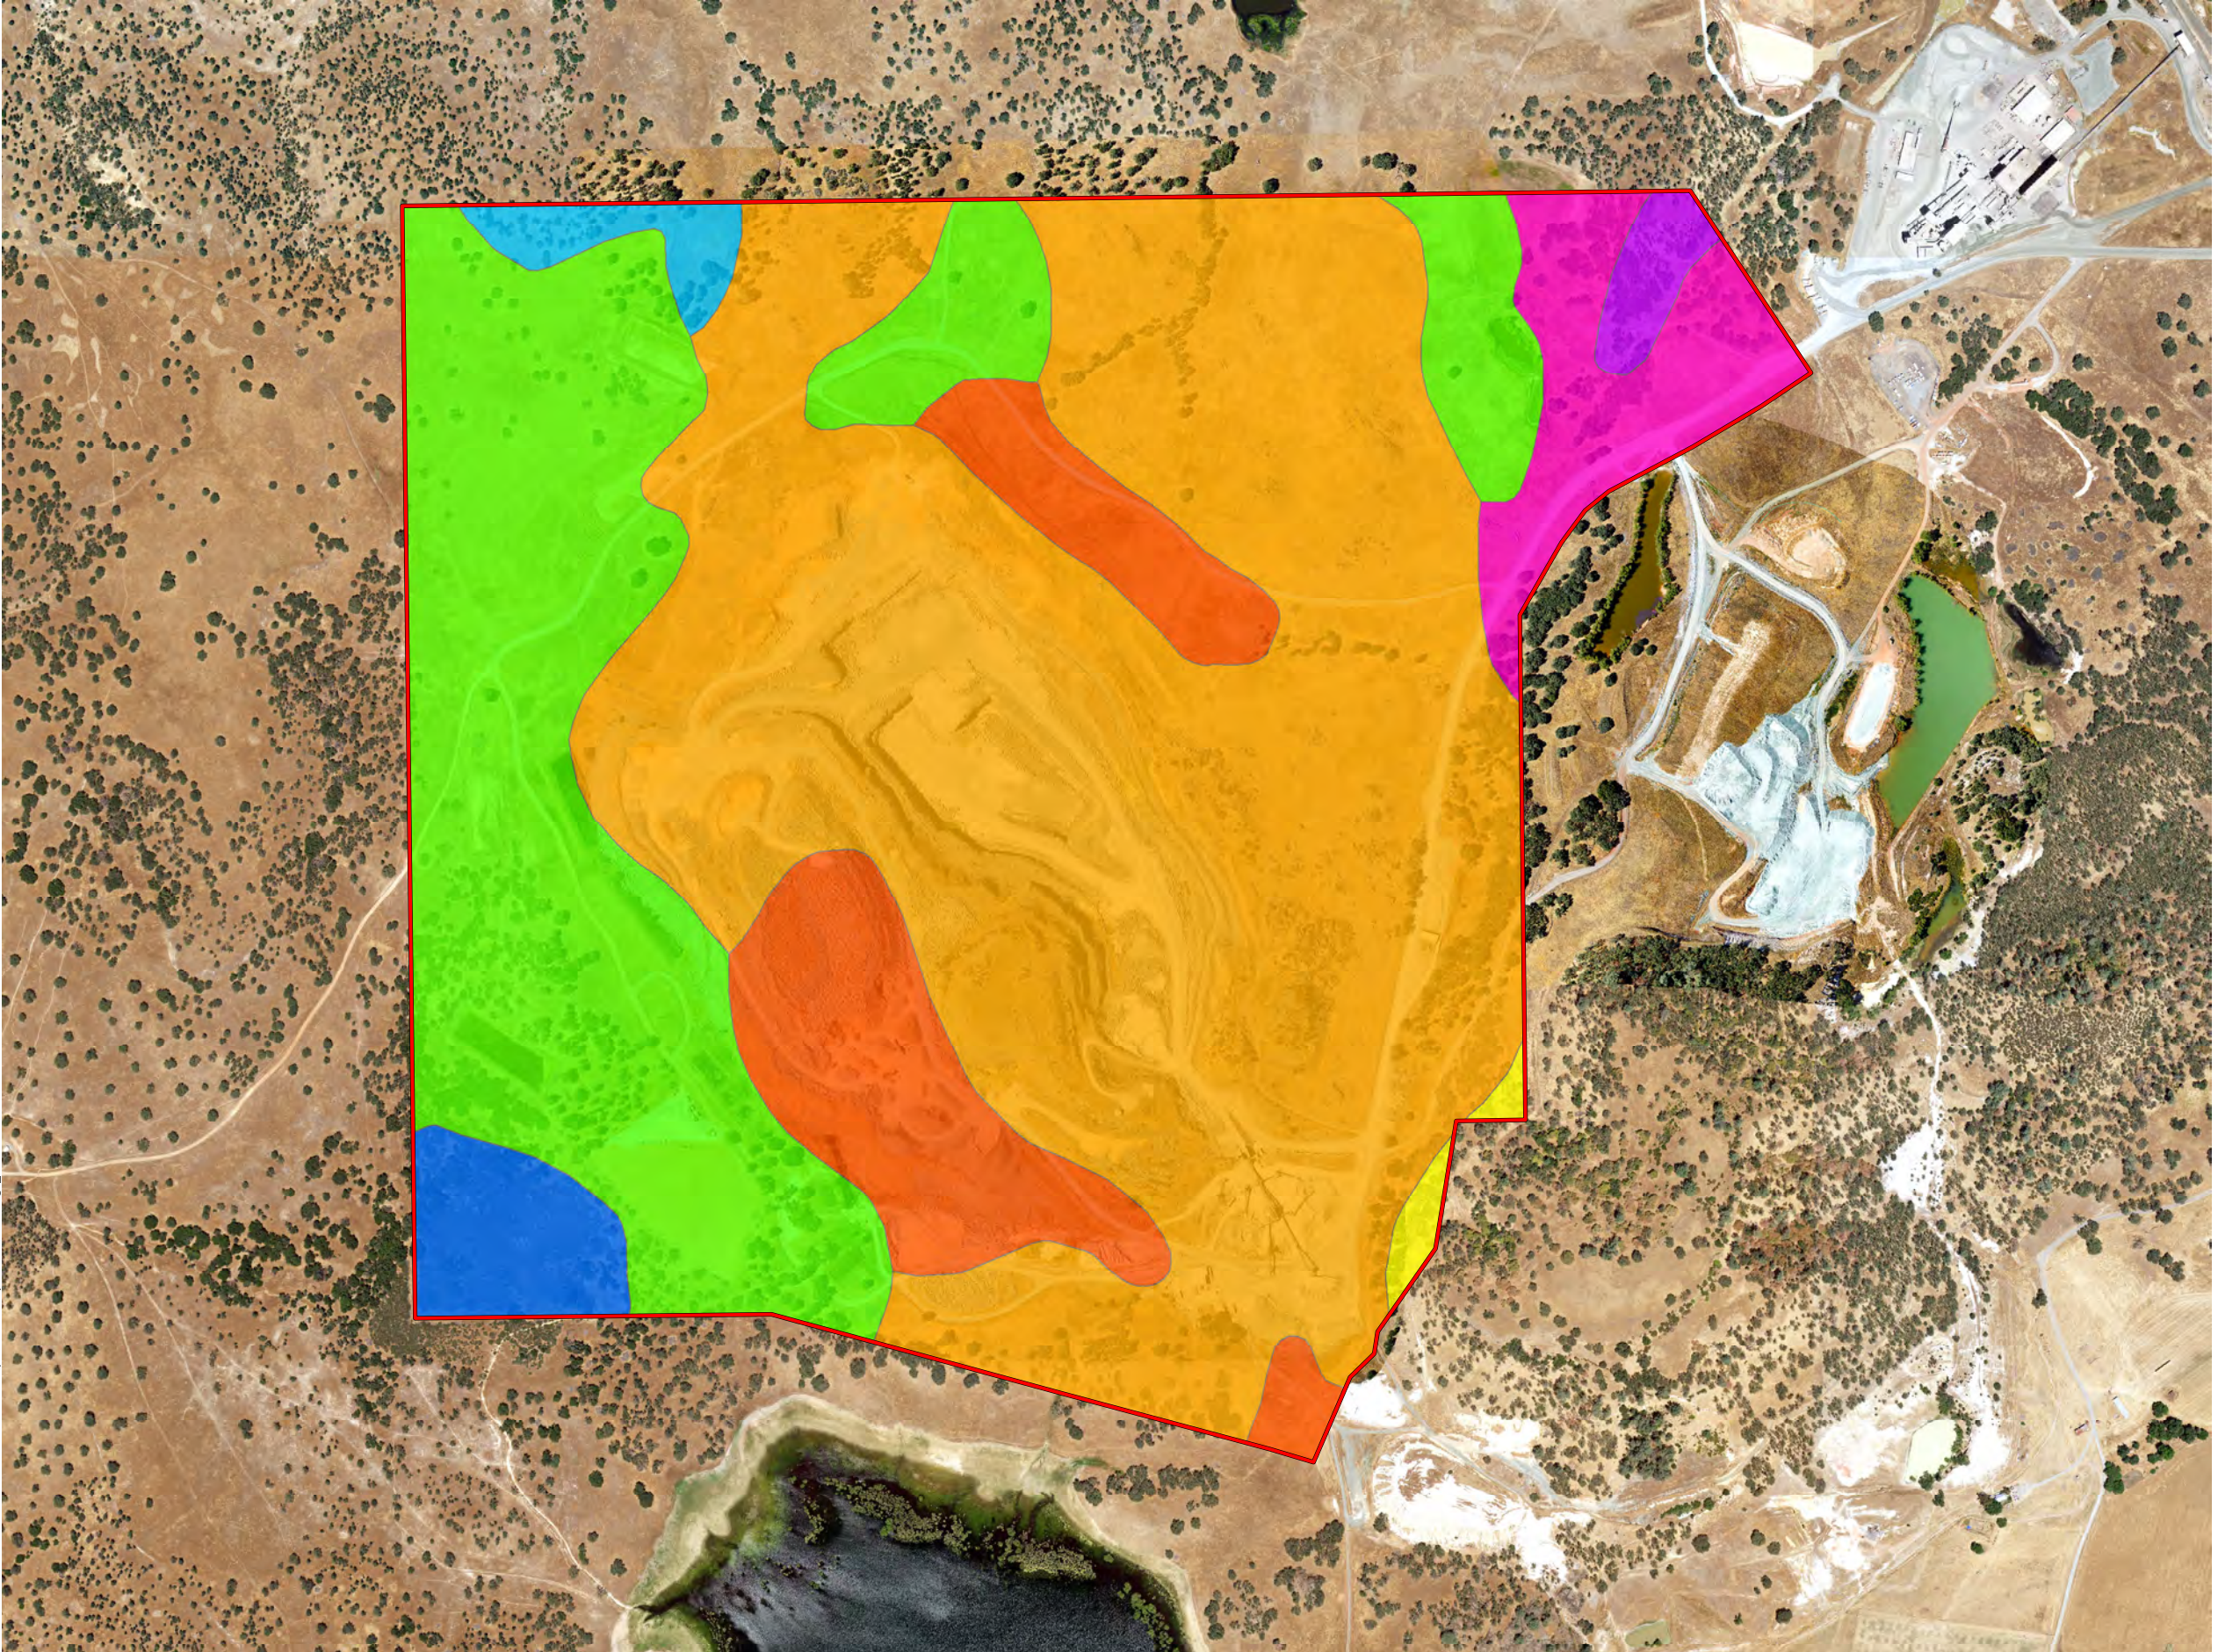
- Project Area
- Auburn-Argonaut silt loams, 0 to 16 percent slopes
- Auburn-Argonaut very rocky silt loams, 3 to 31 percent slopes
- Inks loam and Rock land, 3 to 45 percent slopes
- Pardee cobbly loam, 3 to 31 percent slopes
- Pentz sandy loam, 16 to 31 percent slopes
- Pentz sandy loam, 2 to 16 percent slopes
- Placer diggings and Riverwash
- Red Bluff-Mokelumne complex, 5 to 16 percent slopes

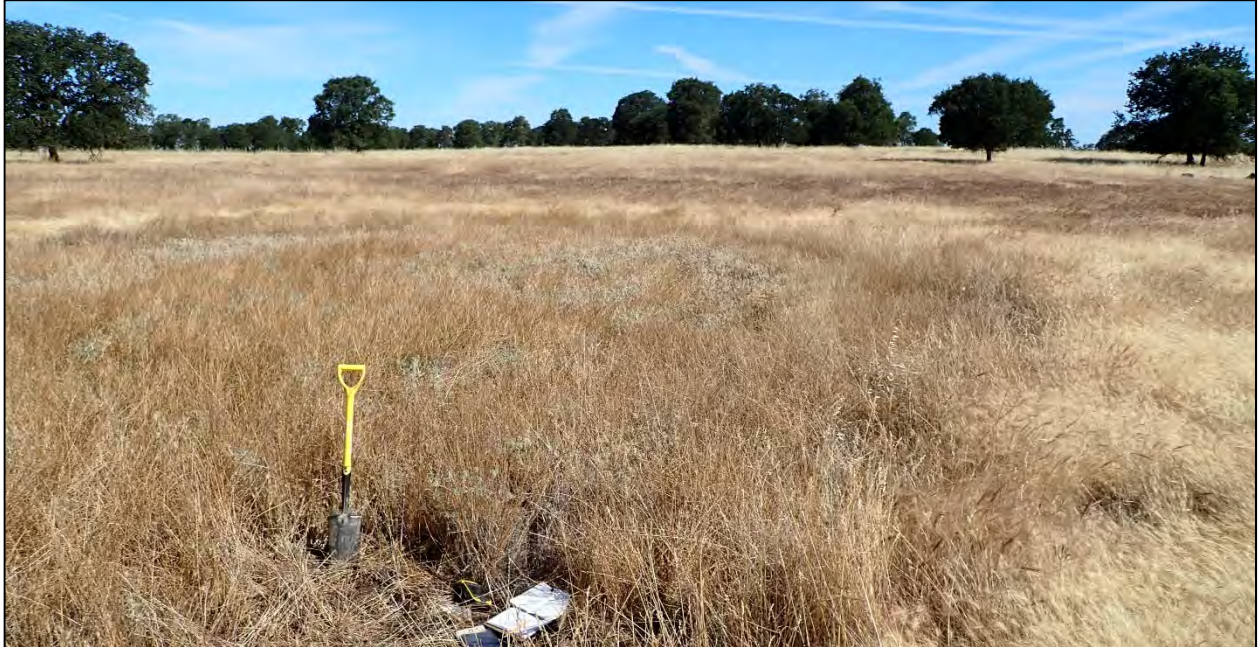
Photograph 1. Photograph depicting potentially jurisdictional vernal pool (VP-06) sampled at SP14. The vernal pool was dominated by Italian ryegrass (*Festuca perennis*), with vernal pool indicator species, coyote thistle (*Eryngium vaseyi*) subdominant. Photo direction is north. Photograph taken June 10, 2020

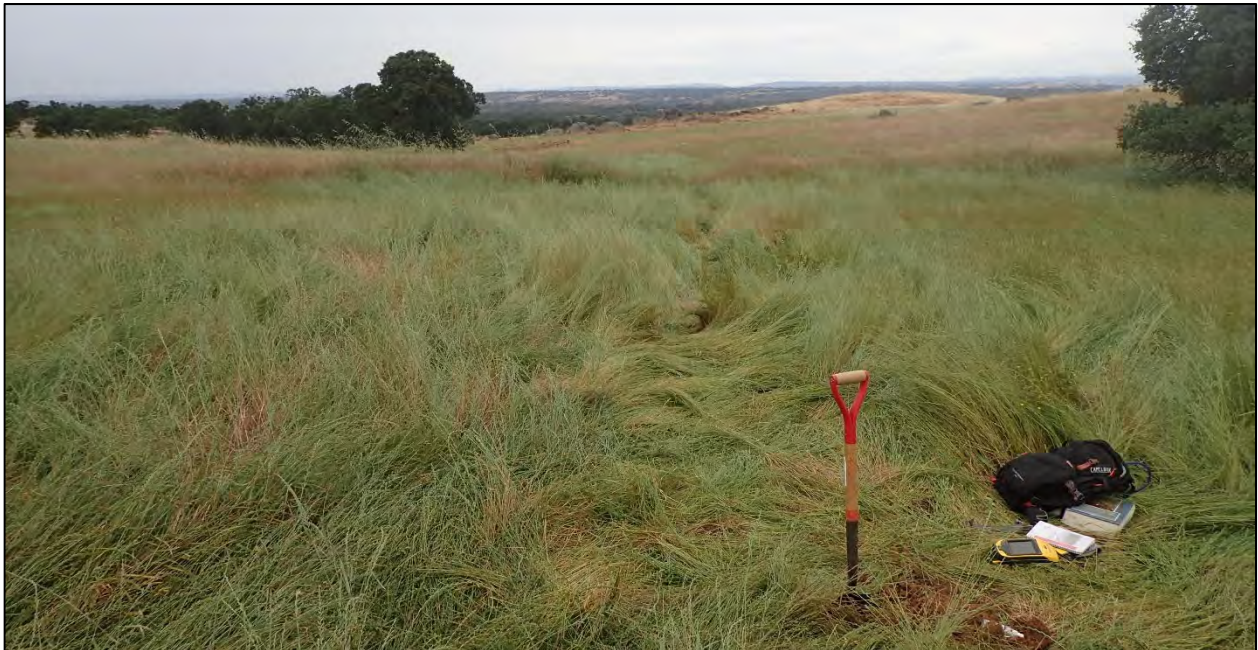
Photograph 2. Seasonal wetland dominated by Italian ryegrass (*Festuca perennis*) in the north-central portion of the Study Area. Upland non-native annual grasslands and blue oak woodland are seen in the background. Photograph taken May 15, 2019. Photo direction is northeast.

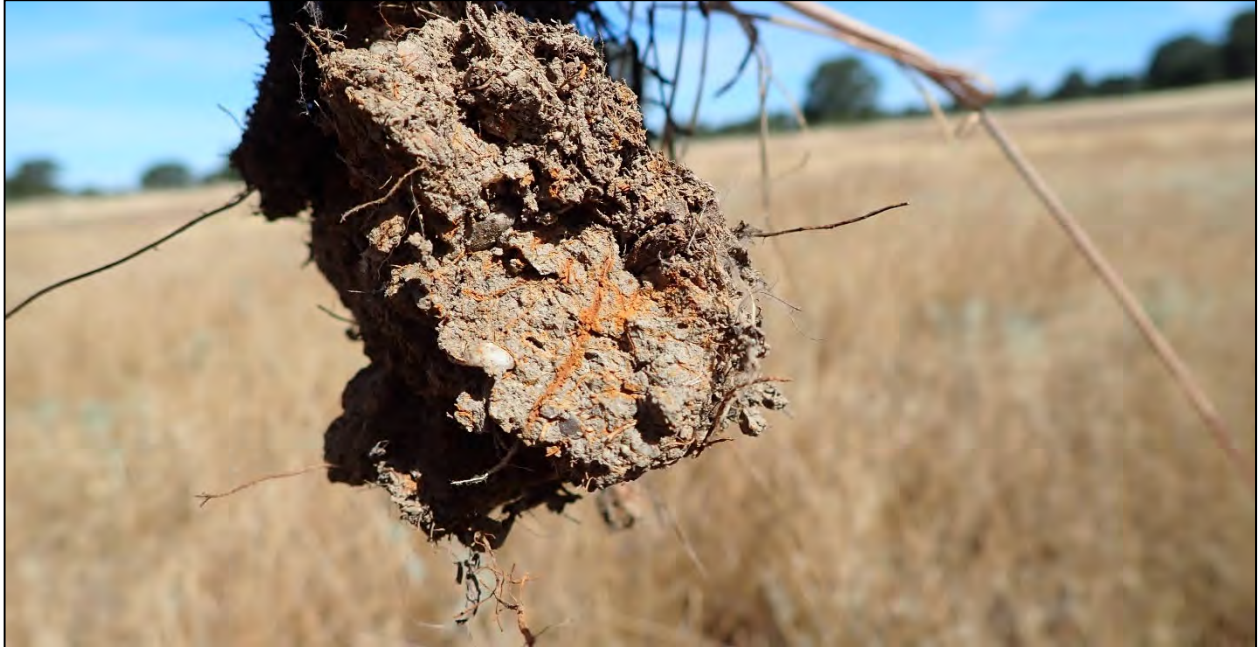
Photograph 3. Photograph depicting soil sample exhibiting depleted matrix, hydric soil indicator F3, sampled within vernal pool VP-06. Photograph taken June 10, 2020.

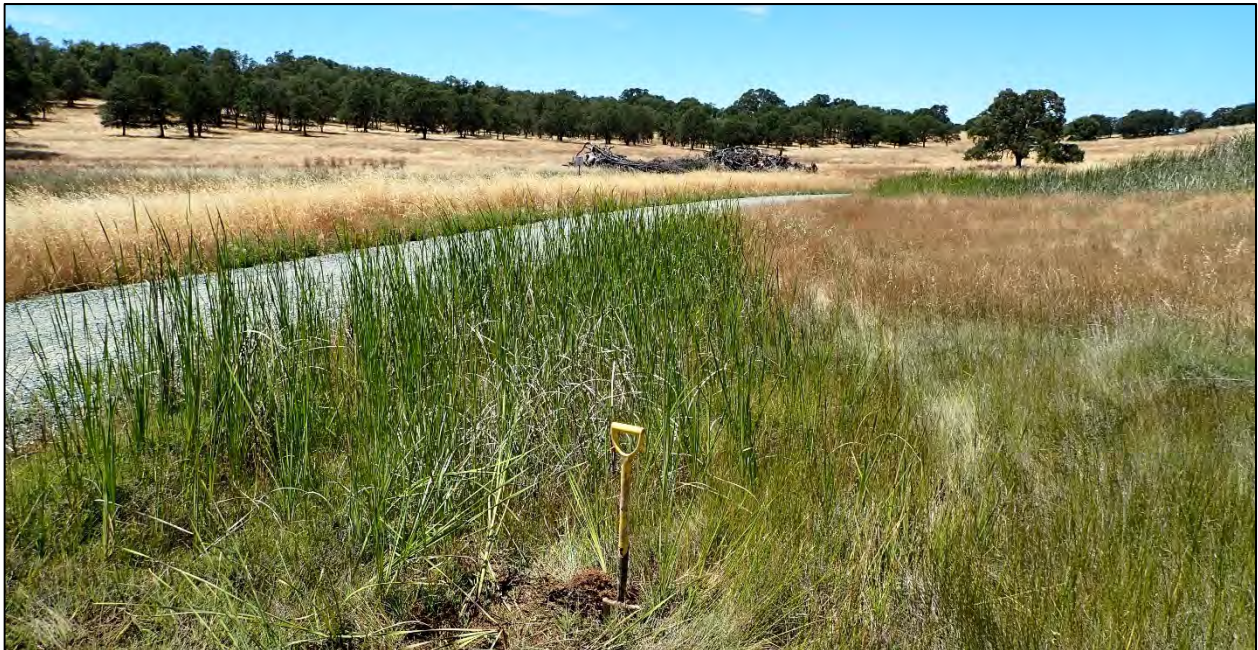
Photograph 4. Photograph depicting potentially jurisdictional freshwater marsh feature, FM-03, sampled at SP09. The feature was dominated by narrowleaf cattail (*Typha angustifolia*), and saltgrass (*Distichlis spicata*), and soils were saturated during the sample date. Photograph taken June 9, 2020.

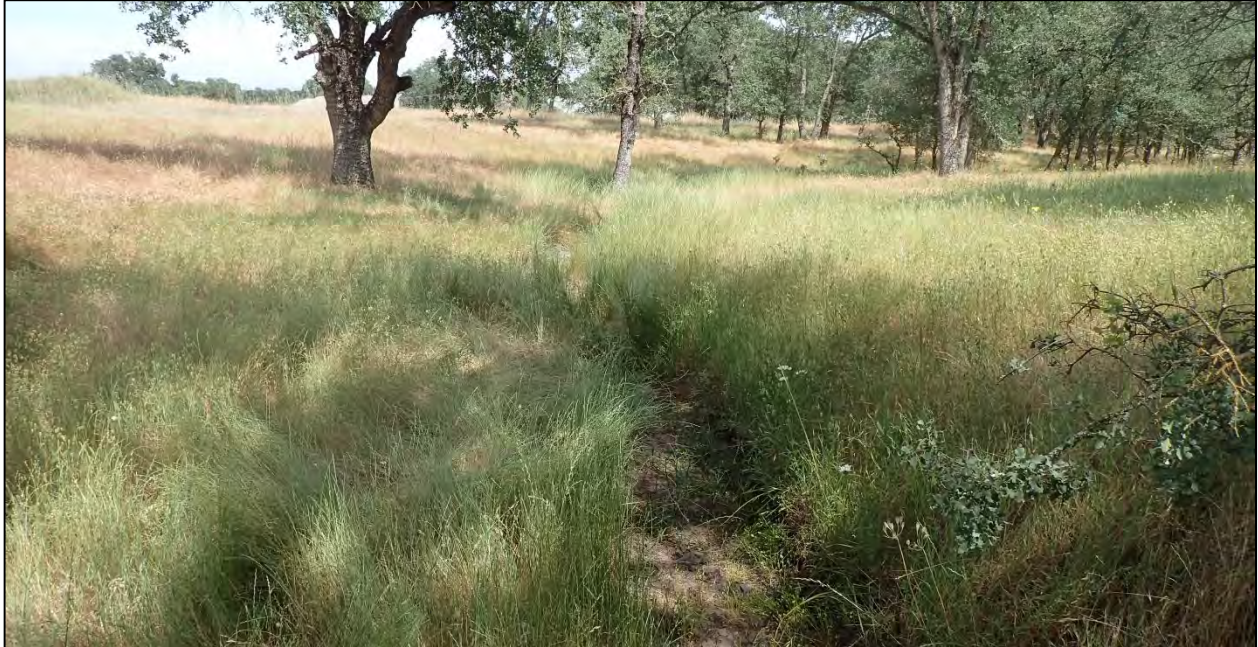
Photograph 5. Photograph depicting an ephemeral stream in the northeastern portion of the Study Area. The ephemeral stream, which was dry during the site visits, flows through blue oak woodland dominated by blue oak (*Quercus douglasii*) and is shown as a 'blue line' stream on the lone and Irish Hill USGS 7.5-minute Quadrangle maps. Photograph taken May 15, 2019.

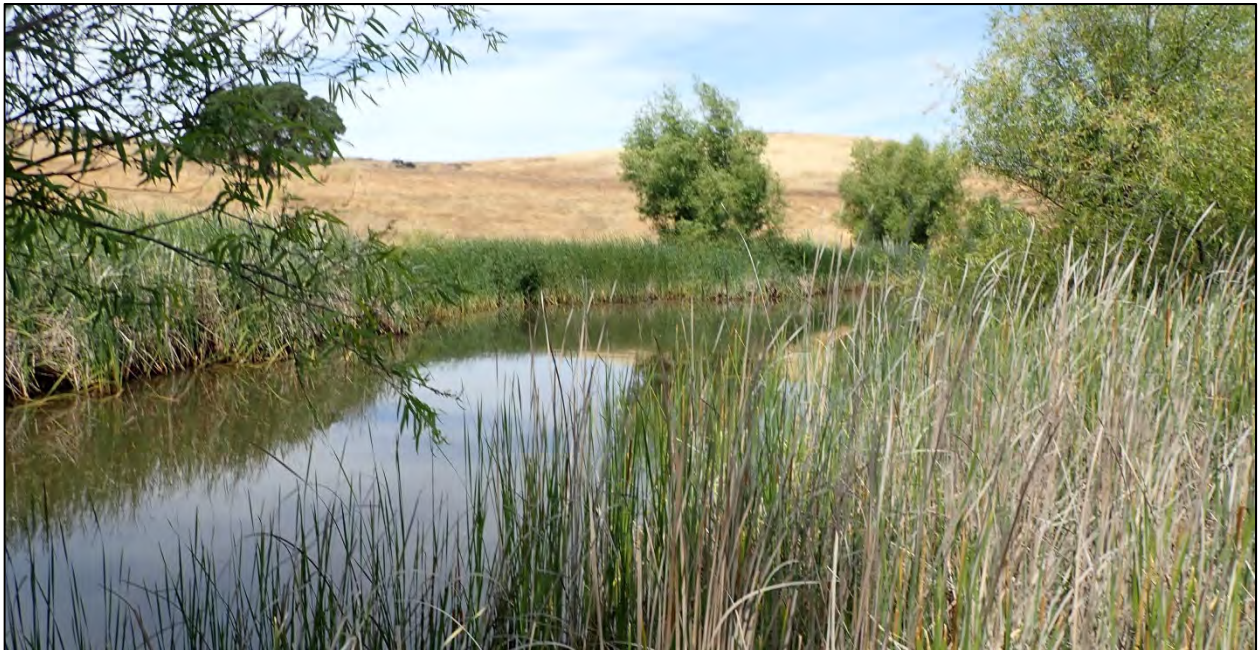
Photograph 6. Potentially jurisdictional pond in the north-central portion of the Study Area. This feature appeared to be originally man-made, but is not in active use, and may be considered jurisdictional. Photograph taken June 10, 2020.

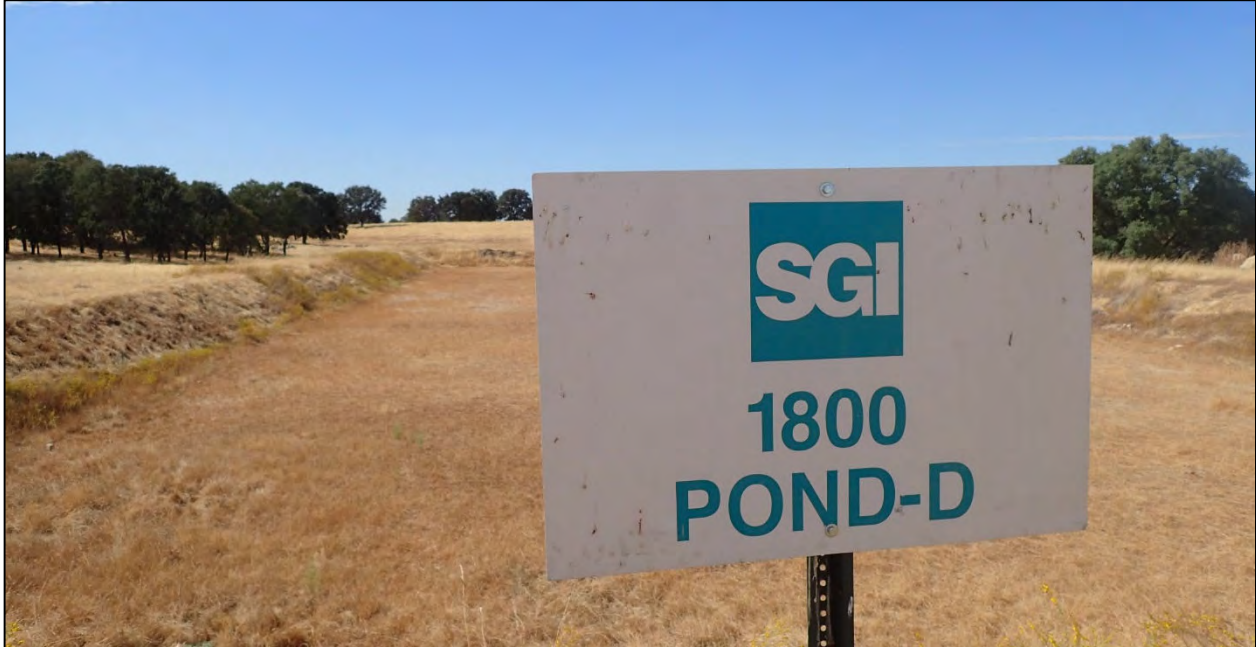
Photograph 7. Non-jurisdictional man-made detention basin (quarry pond) located in the northwest corner of the Study Area. Photograph taken June 10, 2020.

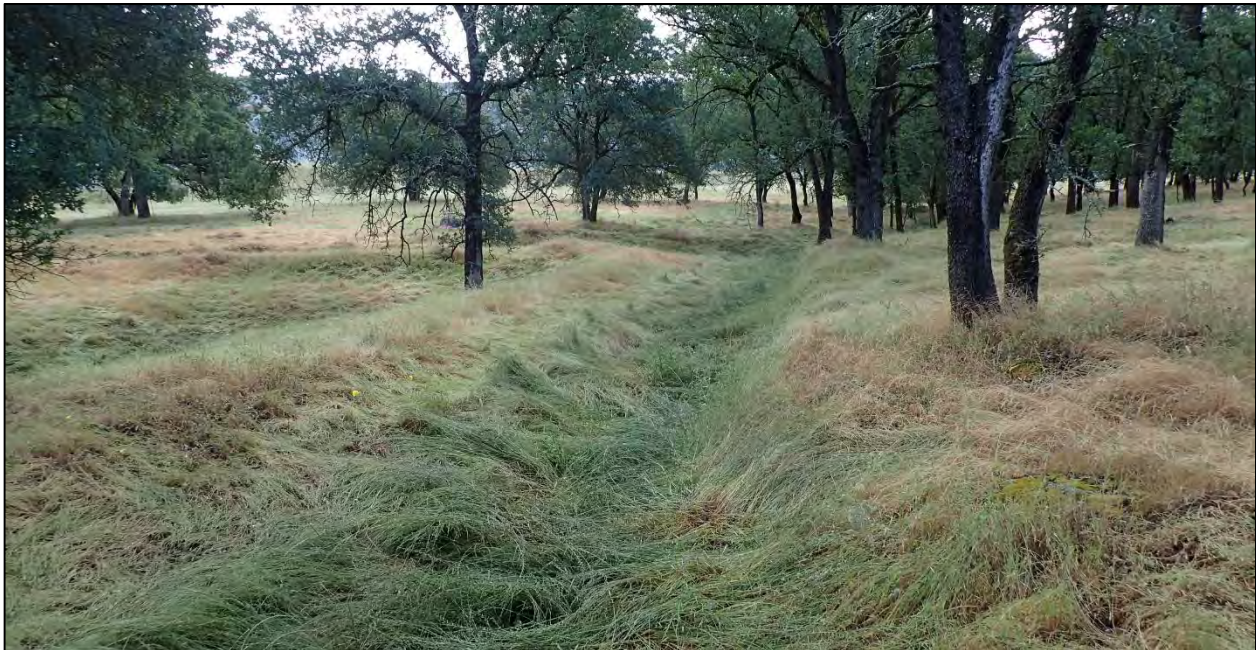
Photograph 8. Non-jurisdictional mining-related drainage ditch located in the southwest portion of the Study Area. This feature terminates in a non-jurisdictional detention basin. Photograph taken May 16, 2019.
